## Categorizing Damage to ACM

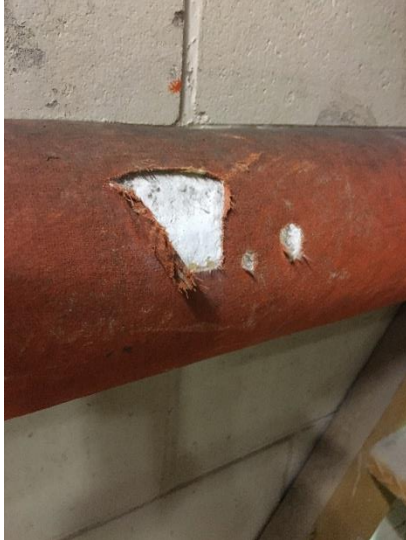
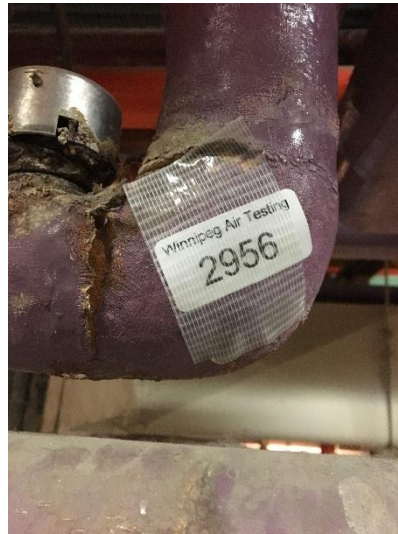
The orange pipe below would be a low degree of damage. The damage is really to the outer non-asbestos layer resulting in exposed but non-damaged asbestos. The purple pipe would also be a Low Damage. It shows significant cracks but at the point where the asbestos elbow joins with the non-asbestos straight insulation. Thus, there is no damage to the asbestos but the elbow has started to give way due to age or impact.

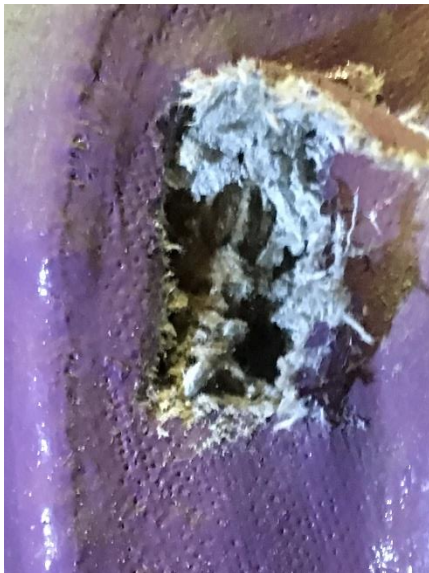
The image below would be a Medium Damage. The damage goes all the way through the outer canvas layer and damaged asbestos is exposed. However, the area is quite small. This is more of a puncture and a limited amount (less than 2 square inches) of ACM is damaged.

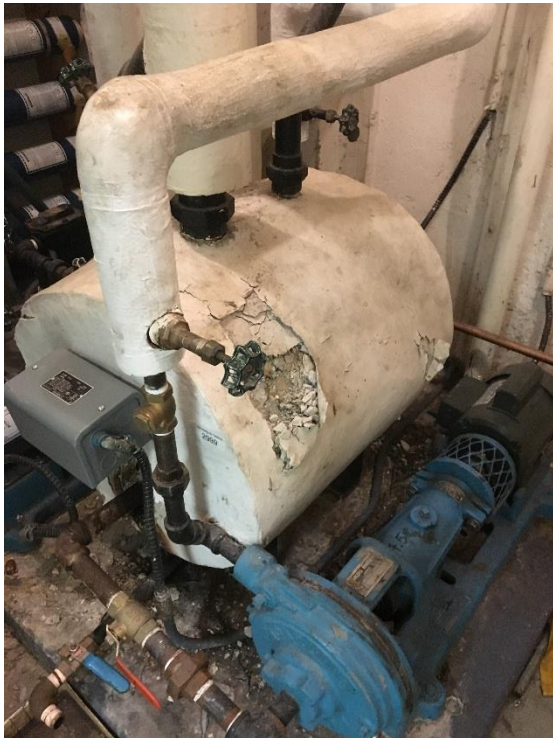
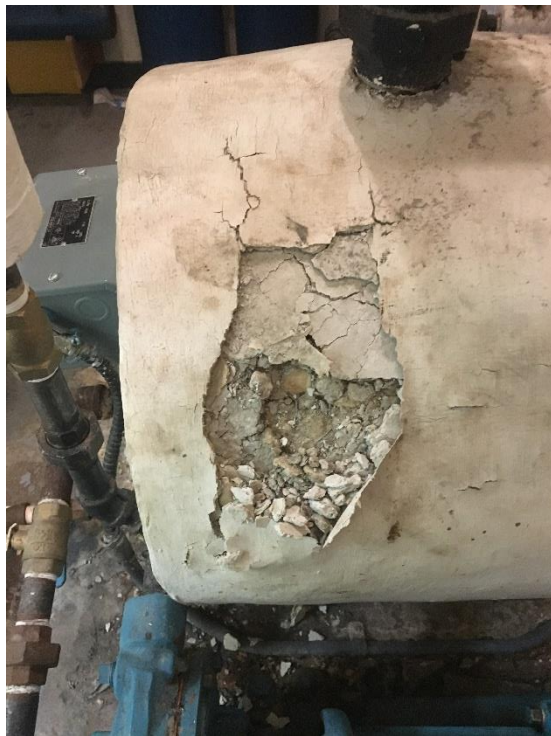
The white tank would be a Severe Damage. There is significant and obvious physical damage to the insulation AND there is visible debris on the floor (right hand image).

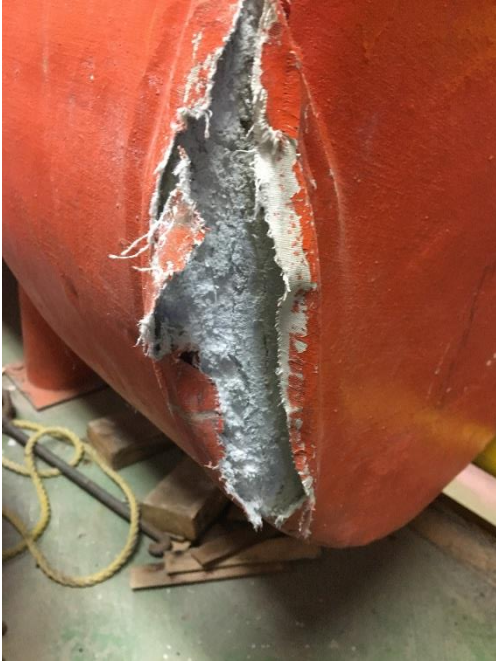
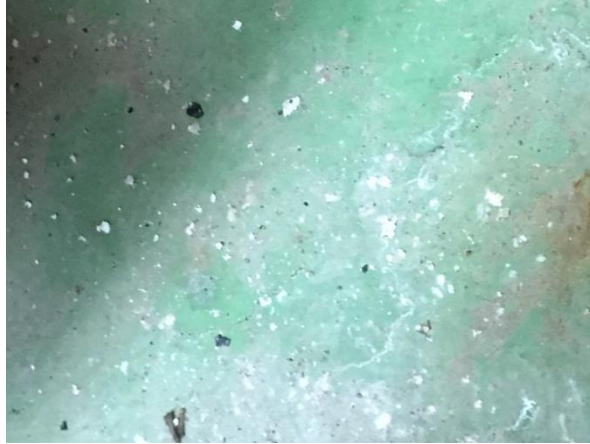
This is a second example of Severe Damage. The end of the structure has come apart exposing a significant amount of ACM. The ACM inside is damaged AND there is debris visible on the floor (right hand image).
