# **Pinchin Environmental & Affiliates**

#### Composition of Asbestos-Containing Drywall Joint Compound (ACDJC)

## Three Typical Field Trials

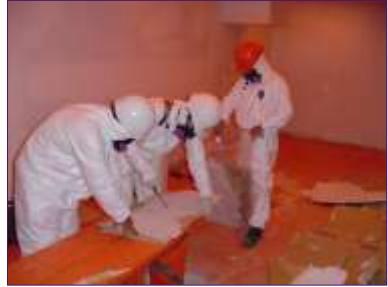
#### Worst case scenarios simulated by saw cutting waste across joints to small pieces (totally dry)

## Test work performed to remove Drywall with ACDJC in totally sealed enclosure

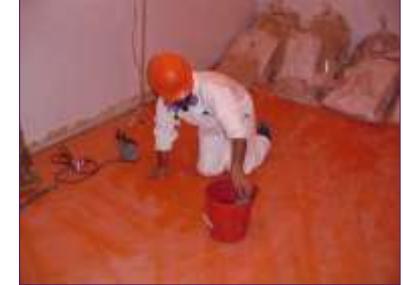
# Material bagged and area wet cleaned. Entire process subject to air monitoring.
